WATER QUALITY RESTORATION PLAN and TOTAL MAXIMUM DAILY LOADS for the NINEMILE PLANNING AREA

Public Review Draft

November, 2004

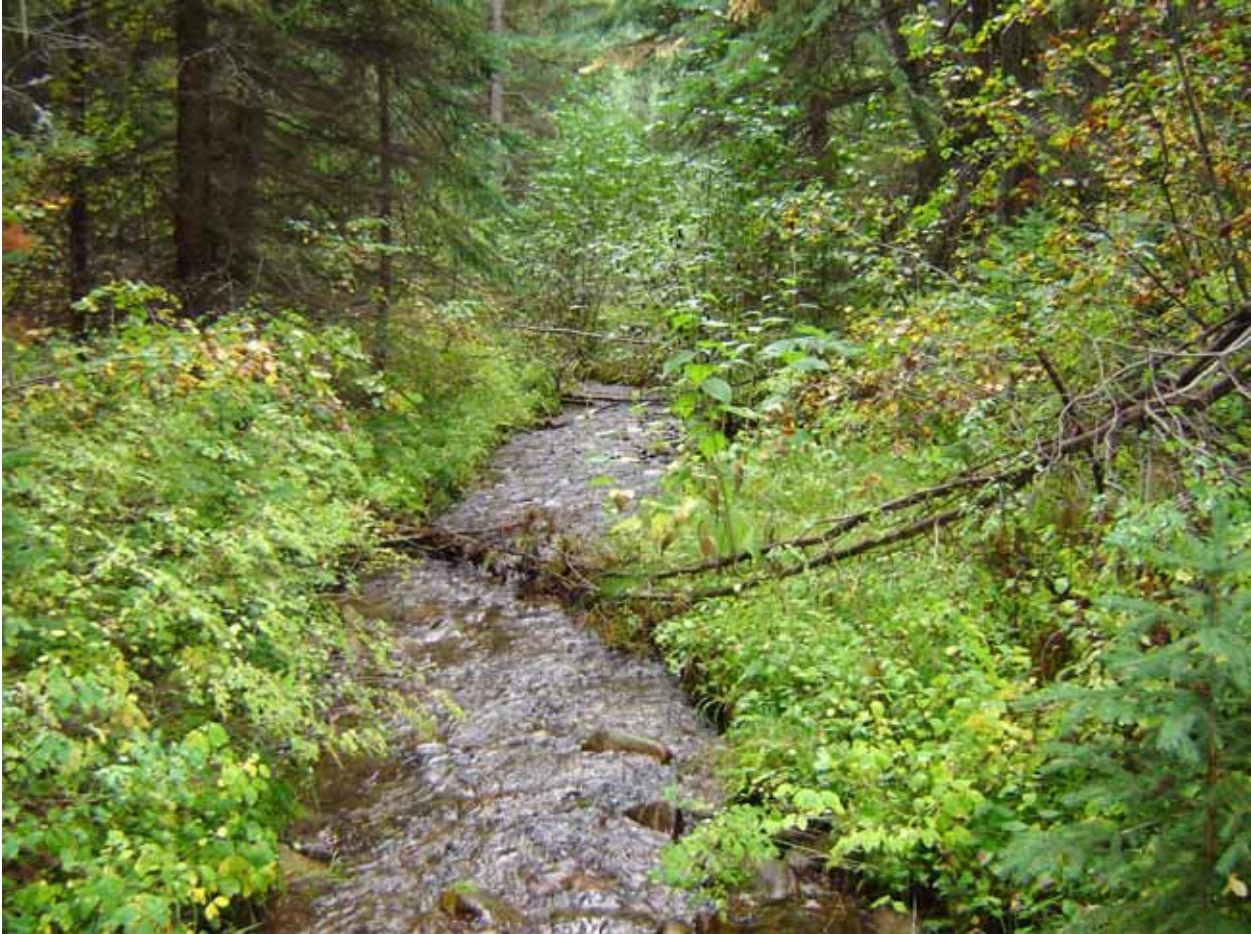
Photo 4-1. Typical Stream Bank Conditions in Big Blue Creek.

Big Blue Creek was listed, in part, due to habitat alterations resulting from agricultural and range sources. As part of the sediment source assessment for Big Blue Creek, a qualitative evaluation of agricultural impacts was conducted as part of the stream bank erosion sediment load assessment. Stream banks within the watershed are generally stable. Big Blue Creek is a small stream that is typically less than 10 feet wide, and banks are low and well vegetated (Photo 4-1). Although some minor sediment load from agricultural and/or range impacts may exist in the watershed, the sources of this load were not identified during source assessment fieldwork and the load was not quantified.

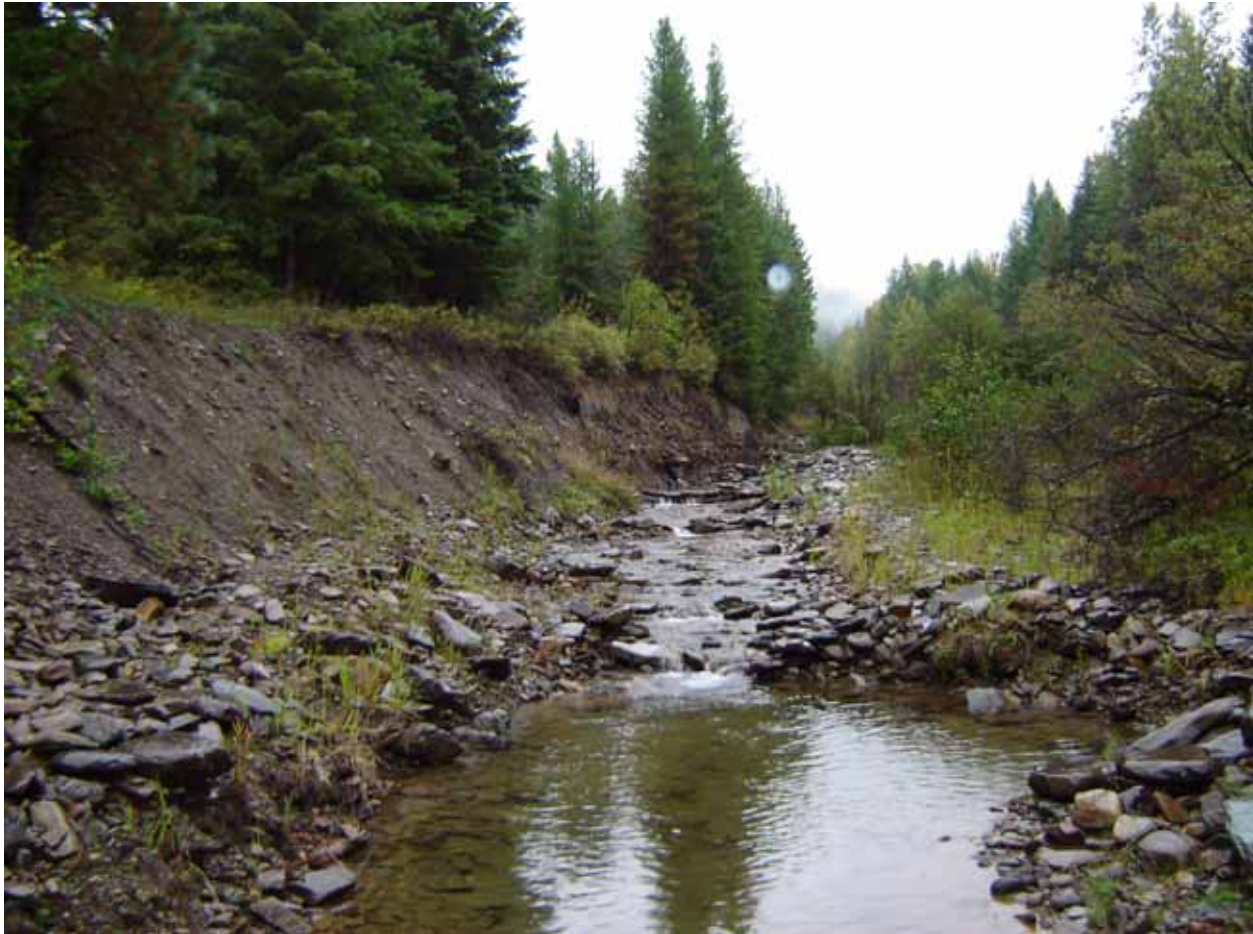
Photo 4-2. Typical conditions in mined sections of Josephine Creek.

A sediment load of 699 ton/year was estimated from human-caused stream bank erosion. All 699 tons/year was attributed to mining, which has impacted approximately 2 miles of Josephine

Creek, or approximately 45 percent of the total stream length. Throughout most of the mined reach, large piles of mine tailings line the stream and prevent channel migration. Although the tailings are revegetated in places, widespread bank instability persists, and in-stream habitat has been simplified by a lack of woody debris recruitment. In some reaches, the mining-induced coarsening of the stream substrate results in subterranean flow during the summer. Typical conditions within the mined reaches of Josephine Creek are presented in **Photos 4-2 and 4-3**.

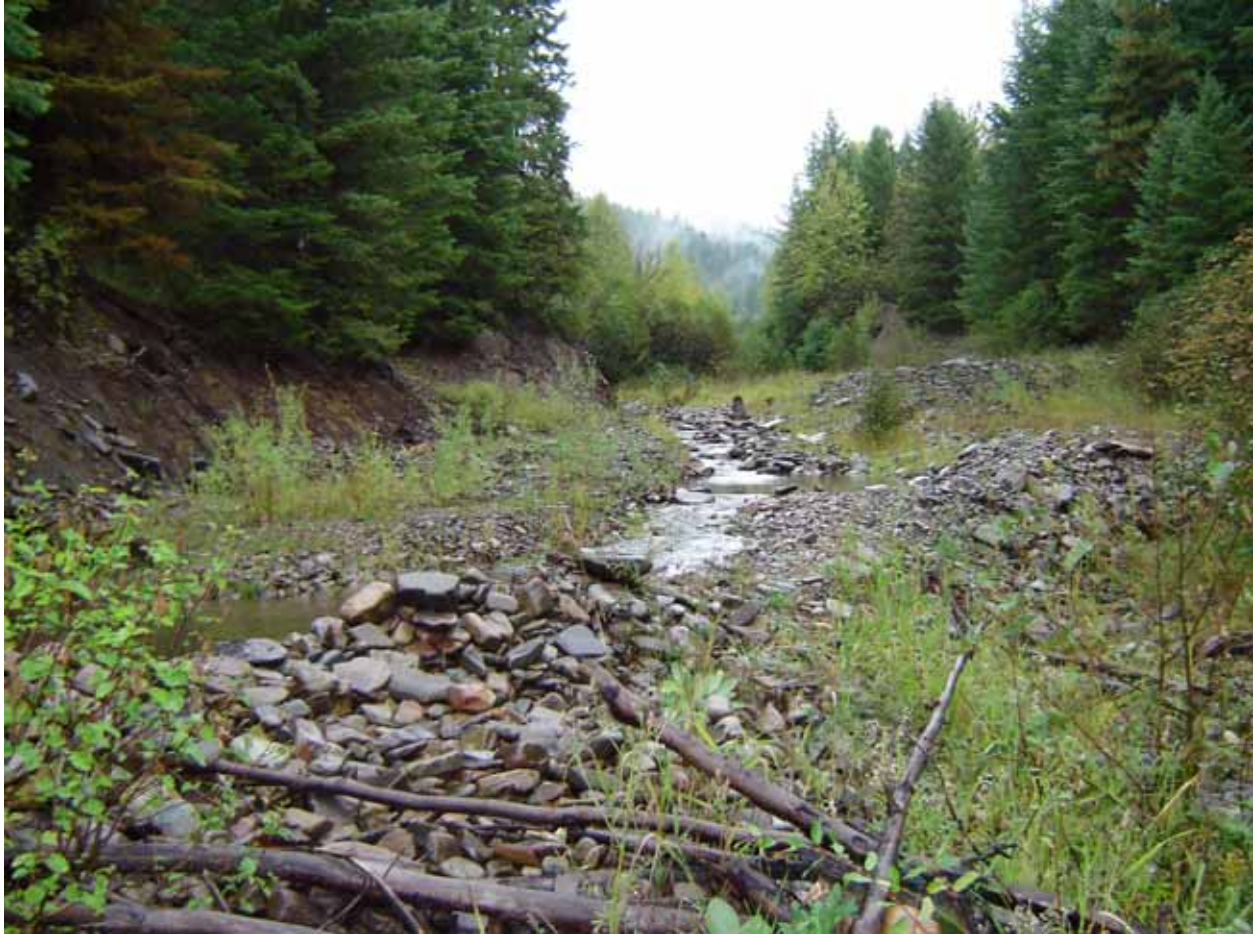
Photo 4-3. Typical conditions in mined sections of Josephine Creek.

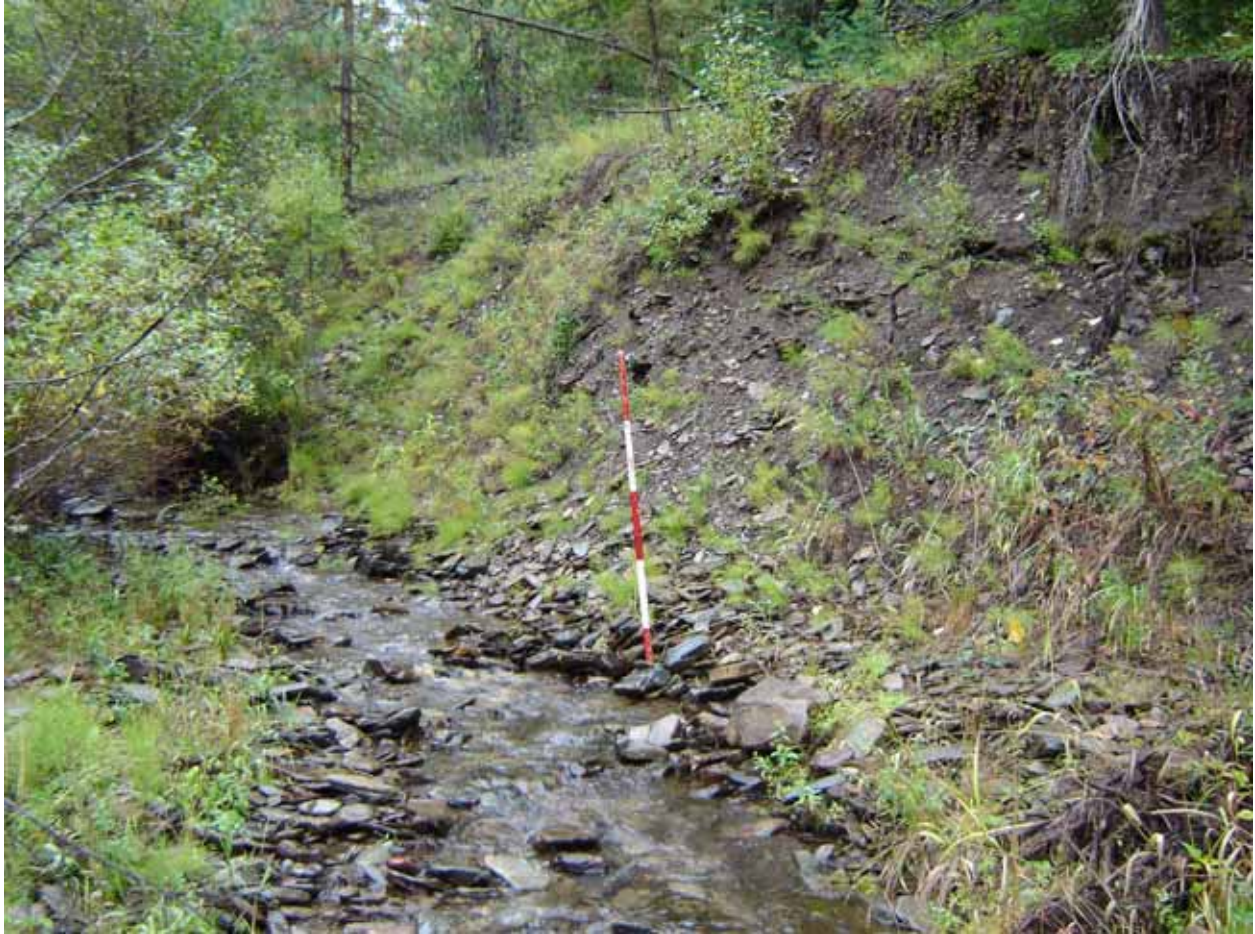
Photo 4-4. Typical conditions in mined sections of Little McCormick Creek.

A sediment load of 1,840 tons/year was estimated from human-caused stream bank erosion (503 from Little McCormick Creek and 1,337 from McCormick Creek). All 1,840 tons/year was attributed to mining, which has impacted approximately 2.2 miles of McCormick and Little McCormick Creeks, or approximately 28 percent of the their combined stream length.

Throughout most of the mined reach, large piles of mine tailings line the stream and prevent channel migration. Although the tailings are revegetated in places, widespread bank instability persists, and in-stream habitat has been simplified by a lack of woody debris recruitment. In some reaches of Little McCormick Creek, the mining-induced coarsening of the stream substrate results in subterranean flow during the summer. Typical conditions within the mined reaches of McCormick and Little McCormick Creeks are presented in **Photos 4-4 and 4-5**.

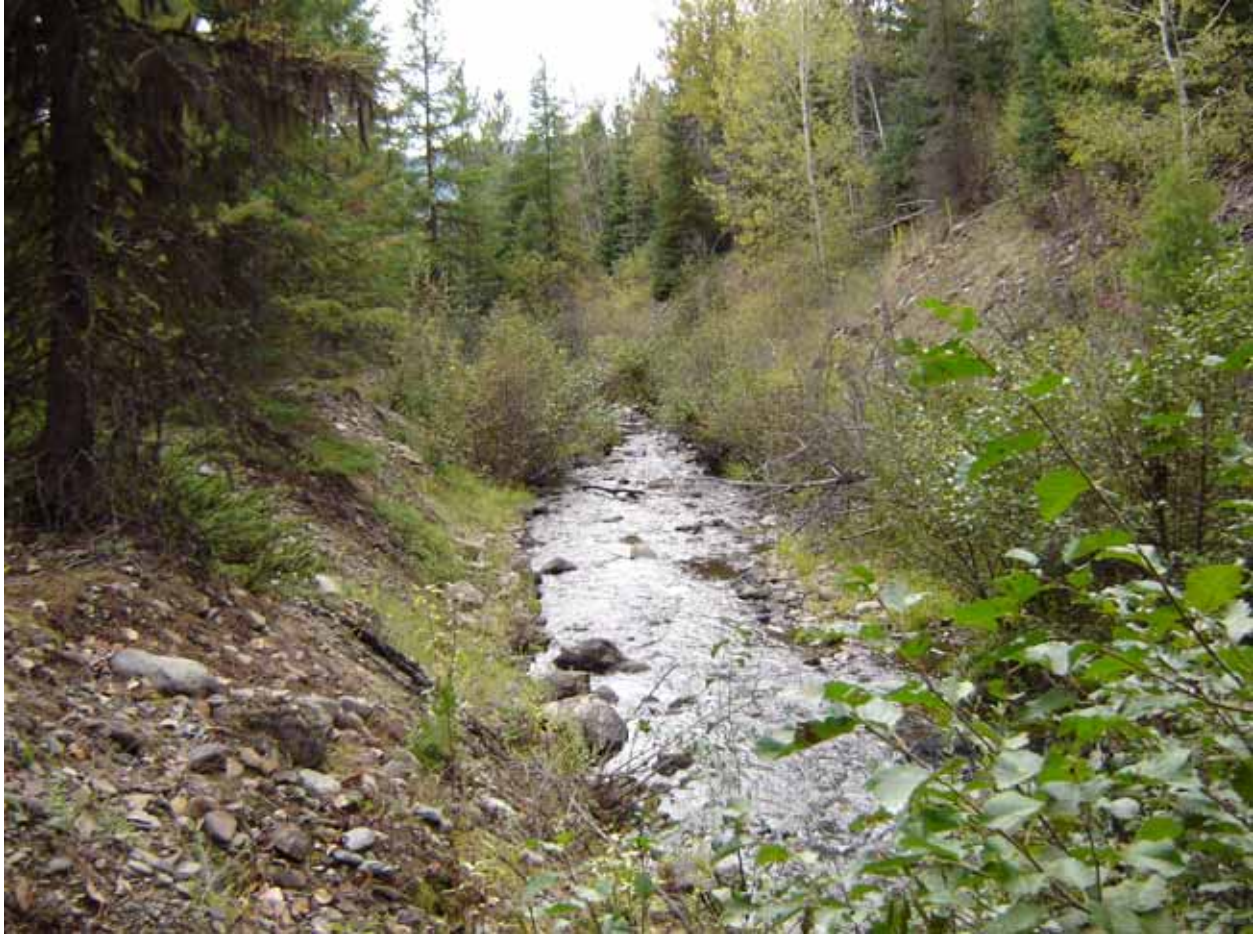
Photo 4-5. Typical conditions in mined sections of McCormick Creek.

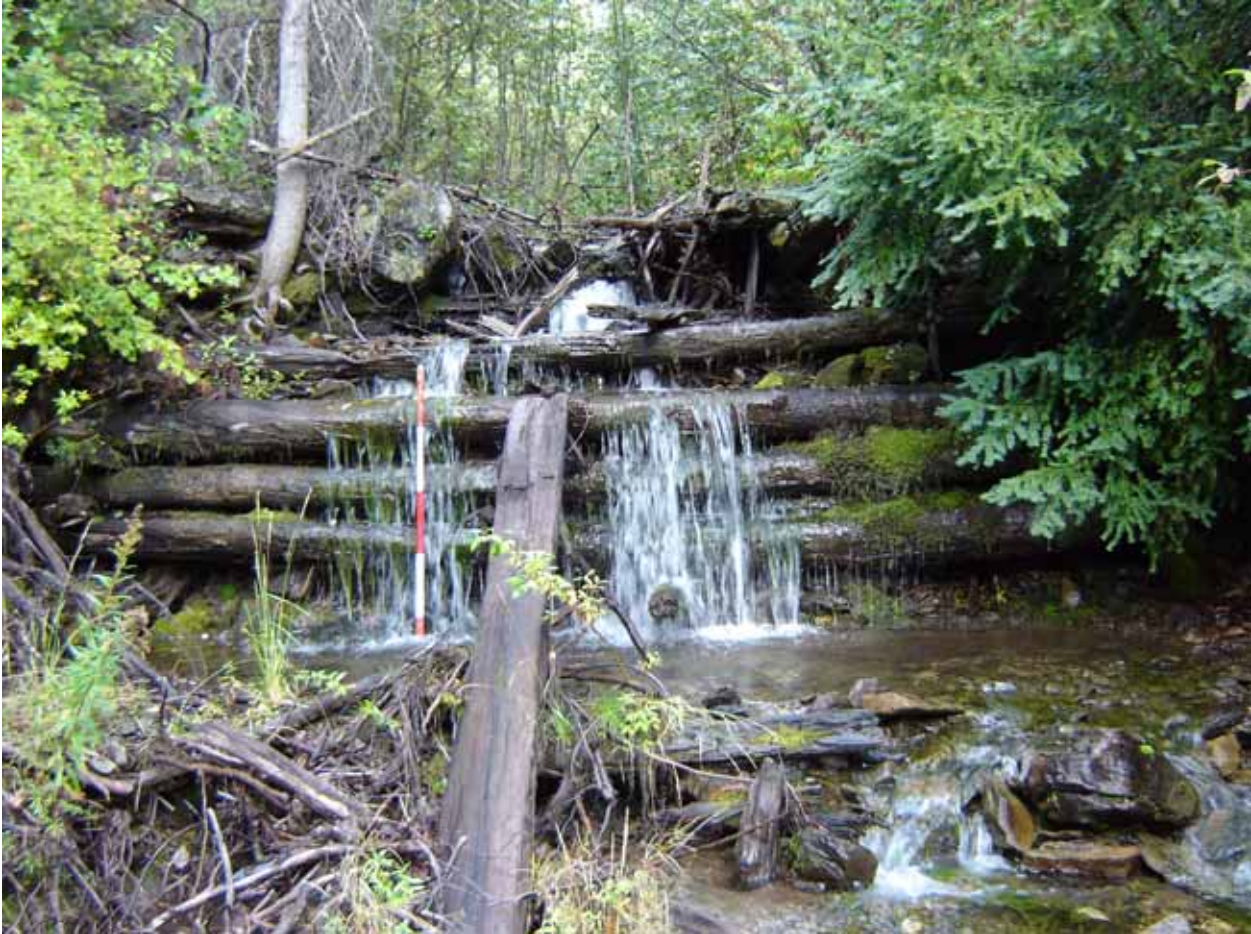
Photo 4-6. Fish passage barrier in Little McCormick Creek.

According to the Lolo National Forest, there is a fish passage barrier on an unnamed tributary to McCormick Creek on forest road 392 in section 1 SWSW $\frac{1}{4}$, which is owned by the Plum Creek Timber Company. It is not know if this section of stream supports fish at this time. The crossing at the Little McCormick Creek confluence is often de-watered from the mining disturbance upstream, and the pipe is partially blocked by alluvium and may be a passage barrier. Depth and flow connectivity are likely a problem under low flow conditions. There are also several fish barriers in Little McCormick Creek as a result of old mining dams (Photo 4-6).

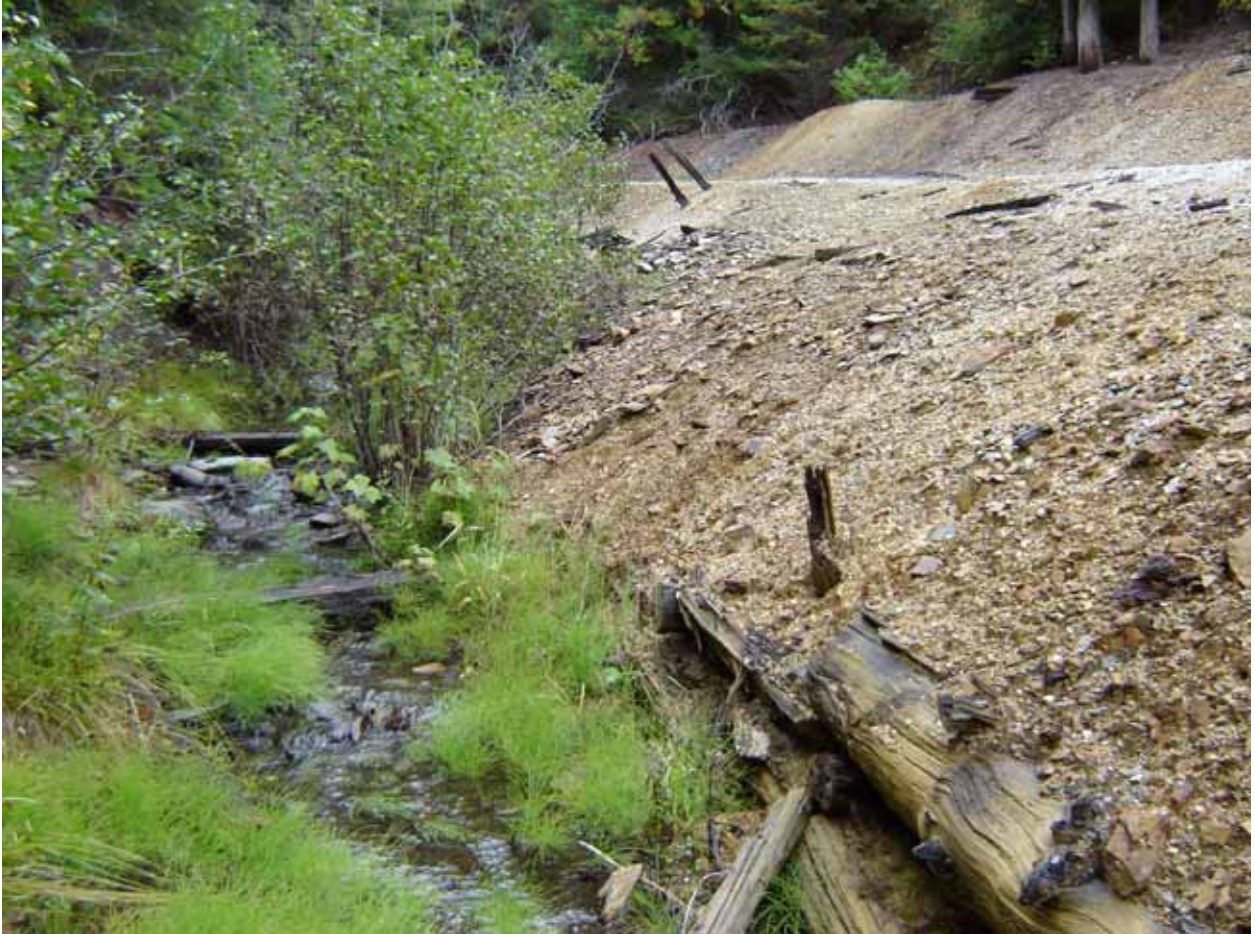
Photo 4-7. Typical conditions in mined sections of Kennedy Creek.

A sediment load of 719 tons/year was estimated from human-caused stream bank erosion. All 719 tons/year was attributed to mining, which has impacted approximately 1.7 miles of Kennedy Creek, or approximately 30 percent of its total stream length. Throughout much of the mined reach, piles of mine tailings line the stream and prevent channel migration. Although the tailings are revegetated in places, bank instability persists. Typical conditions within the mined reaches of Kennedy Creek are presented in **Photos 4-7 to 4-8**.

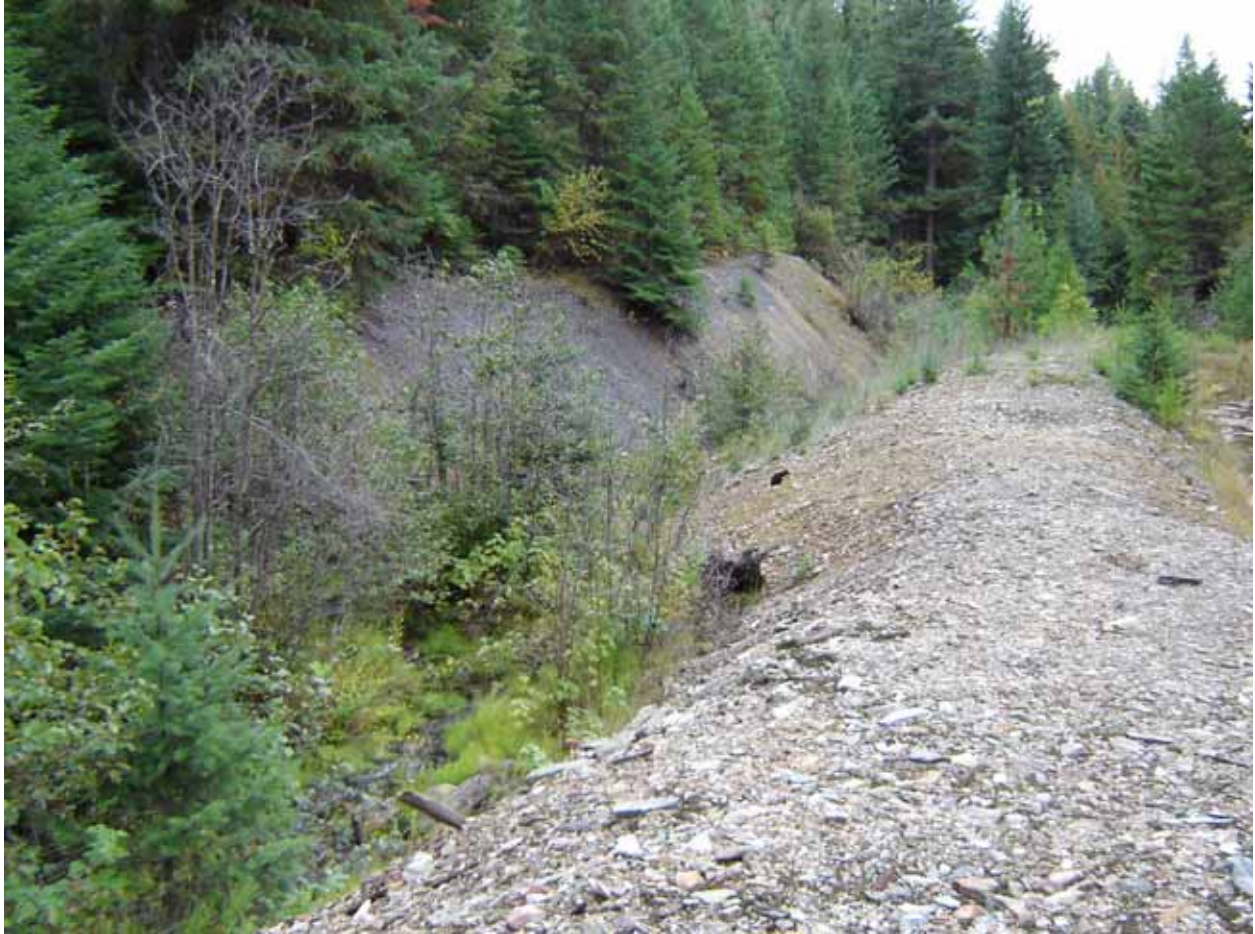
Photo 4-8. Typical conditions in mined sections of Kennedy Creek.

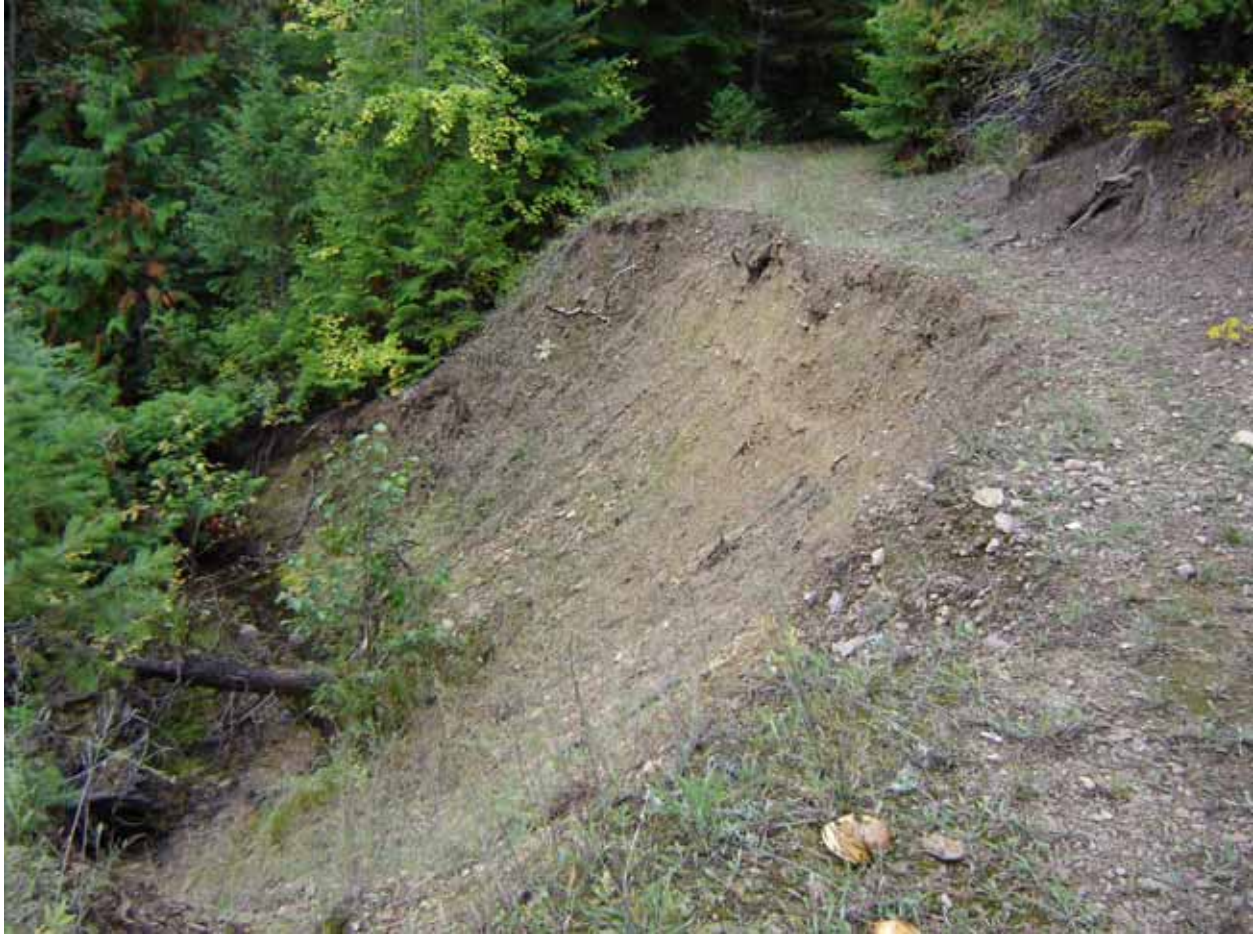
Photo 4-9. Road failure on Kennedy Creek.

As described above, approximately 1.7 miles of Kennedy Creek have been altered by placer mining. Additionally, 1.8 miles of road encroach to within 100 feet of the stream, a distance equal to approximately 32 percent of the stream's length. The road along Kennedy Creek has collapsed in at least one location (Photo 4-9).

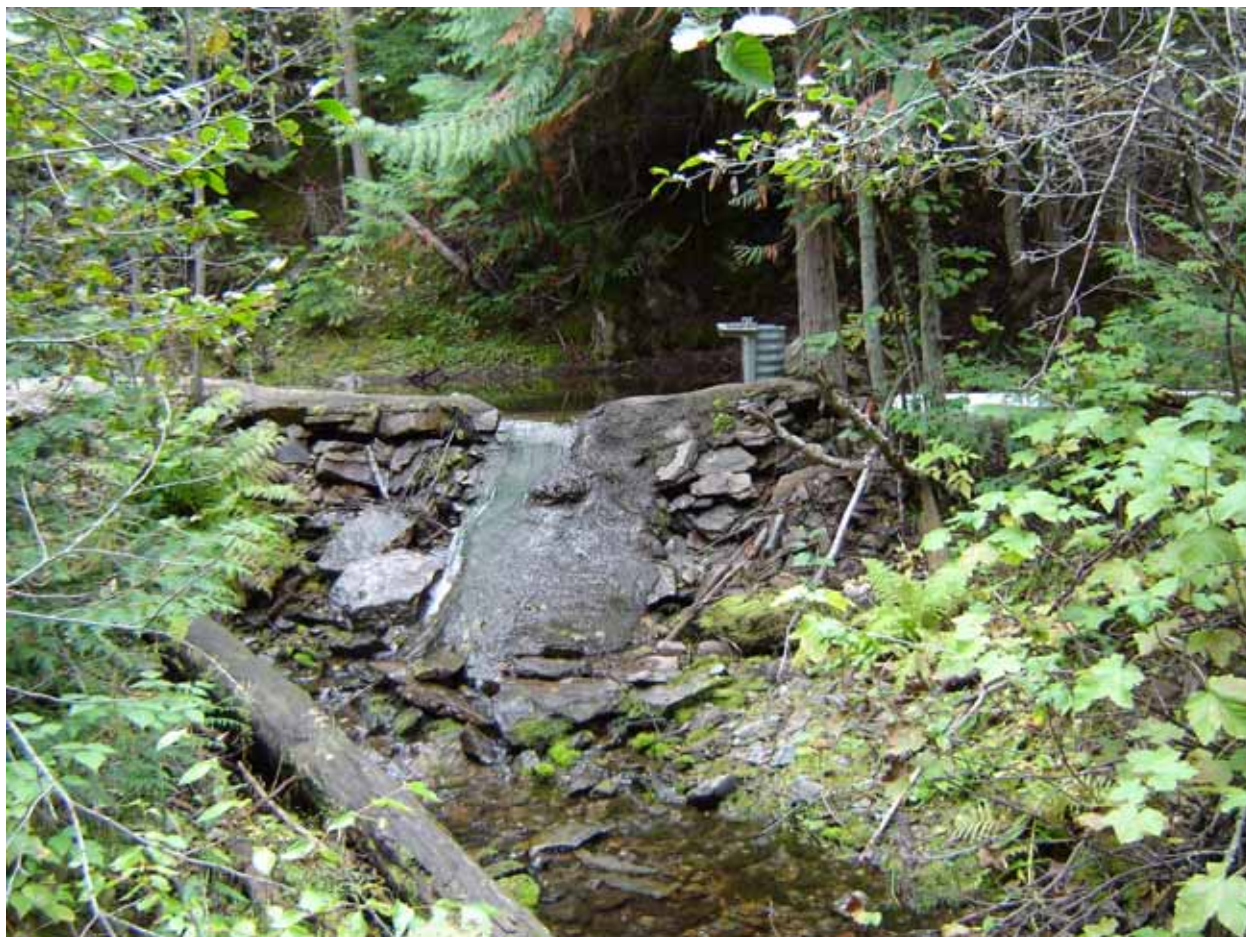
Photo 4-10. Fish passage barrier on Kennedy Creek.

At least two fish passage barriers exist on Kennedy Creek. At the lower end of the mining complex there is an irrigation diversion pond that is a complete fish passage barrier at most flows (Photo 4-10), and there is a culvert on a private road crossing on lower Kennedy Creek that is a probable fish passage barrier.

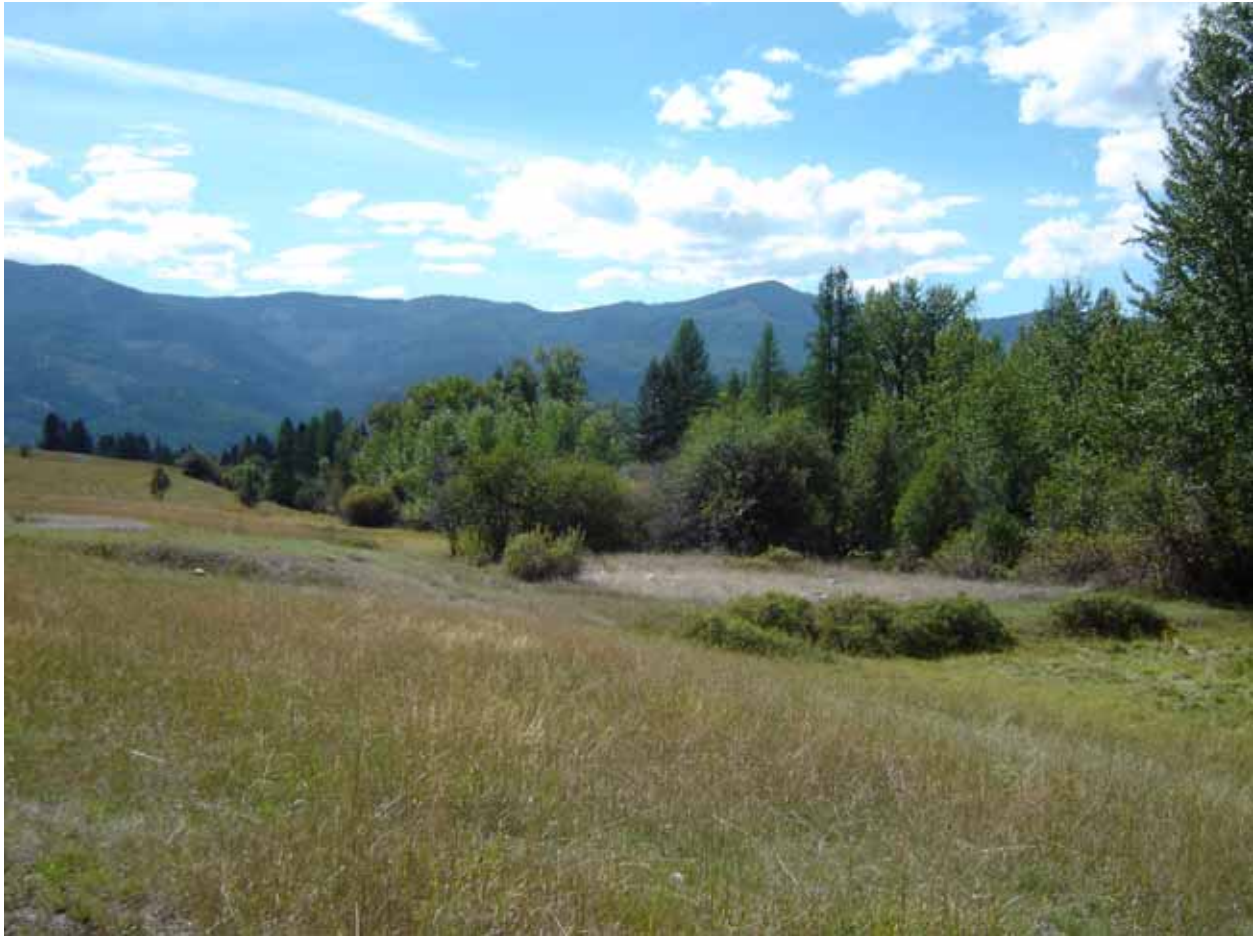
Photo 4-11. Stony Creek riparian zone in Lolo National Forest Pasture.

Stony Creek was listed, in part, due to siltation and habitat alterations resulting from agricultural, range, and irrigated sources. As part of the sediment source assessment for Stony Creek, a qualitative evaluation of agricultural impacts was conducted as part of the stream bank erosion sediment load assessment. Results of the assessment indicated that stream banks within the watershed are generally stable. Stony Creek is a small stream that is typically less than 10 feet wide, and banks are low and well vegetated (Photo 4-11 and 4-12). Although some minor sediment load from agricultural and/or range impacts may exist in the watershed, the sources of this load were not identified during source assessment fieldwork and the load was not quantified.

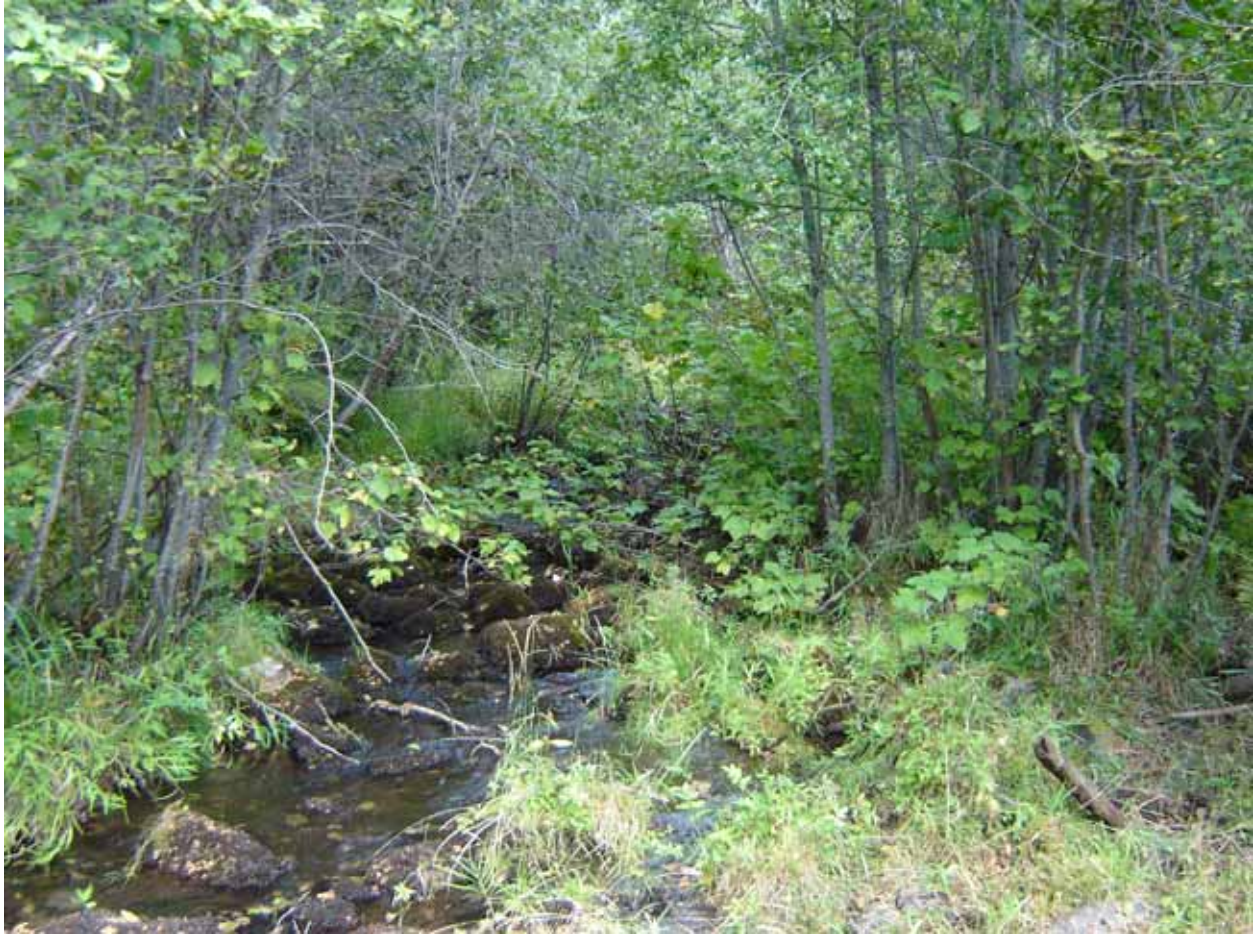
Photo 4-12. Typical conditions in grazed sections of Stony Creek.

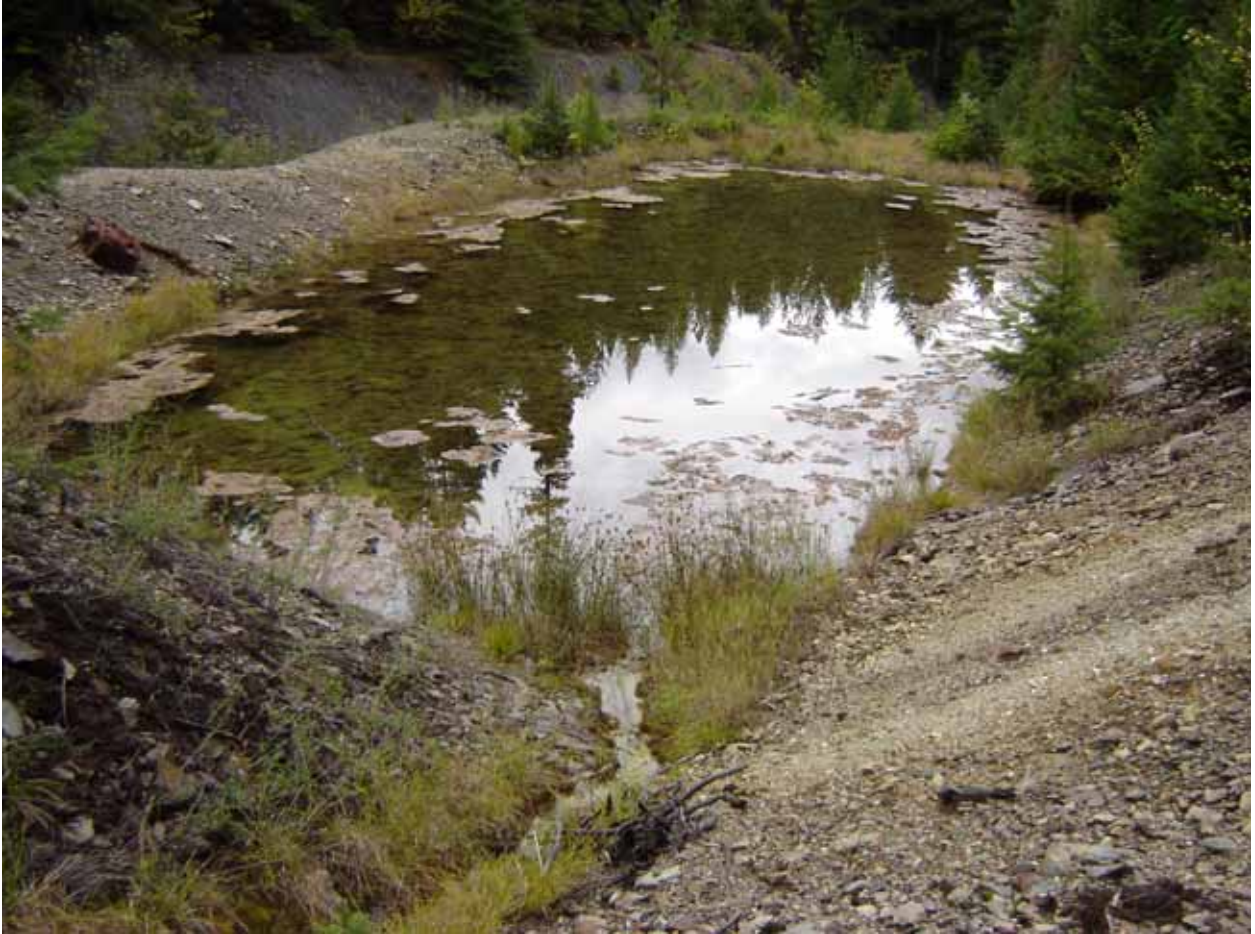
Photo 4-13. Pond of Adit discharge Water at Nugget Mine on Kennedy Creek.

Historic mining disturbances comprise the main known sources of metals to Kennedy Creek. Mining impacts are evident beginning in the northeast corner of section 13 and continuing downstream almost to the county road near the confluence with Ninemile Creek. At the upper end of the mining complex is the Hauttula mine, a copper prospect that historically had a 150-foot adit. The current condition of the adit is unknown. Approximately ½ mile downstream from the Hauttula mine is the Lost Cabin mine, a group of 6 unpatented claims at which several adits were developed. Further downstream from the Lost Cabin Mine is the Nuggets Mine, where water from the adit discharges to a holding pond and then directly to Kennedy Creek. Much of Kennedy Creek between the upper end of the mining complex and the county road has also been placer mined. (Photo 4-13 and 4-14).

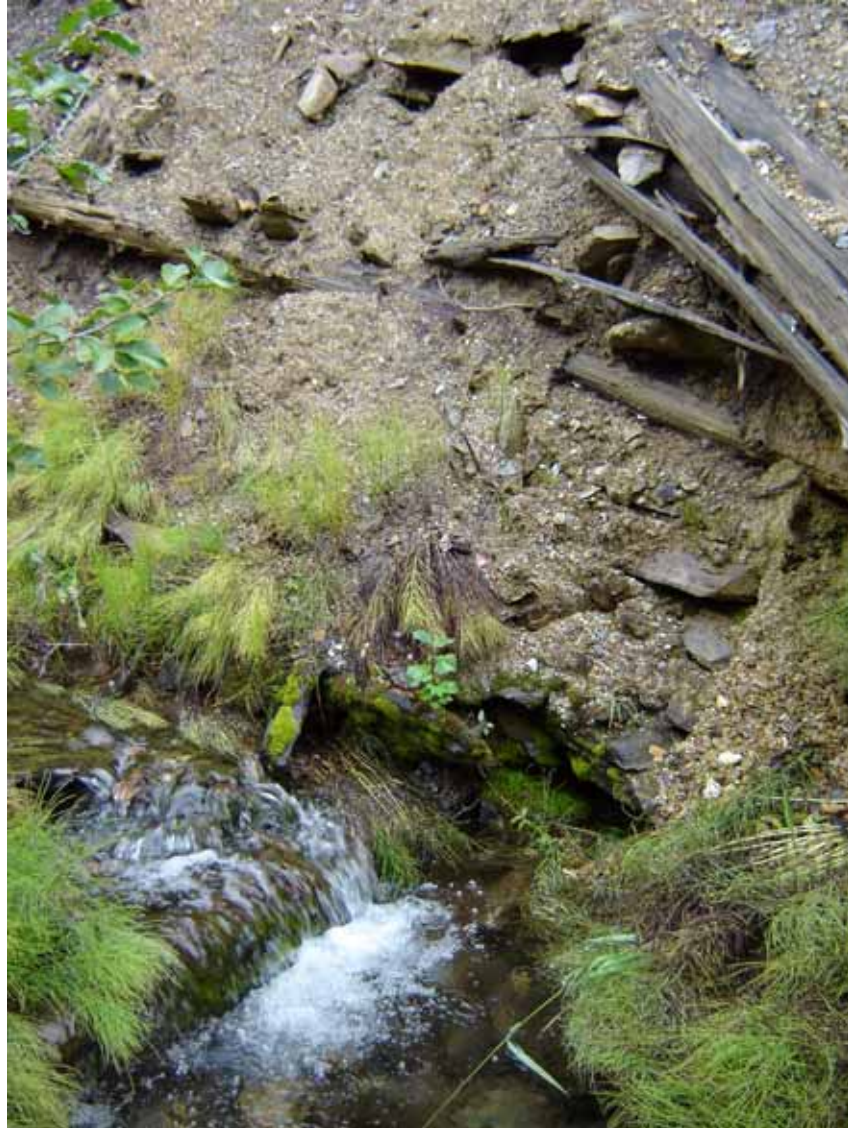
Photo 4-14. Mine Tailings Loading on Kennedy Creek near Lost Cabin Mine.
